## Pelvic - Trauma

Gary Siskin, MD, FSIR, Albany Medical Center, Albany, NY

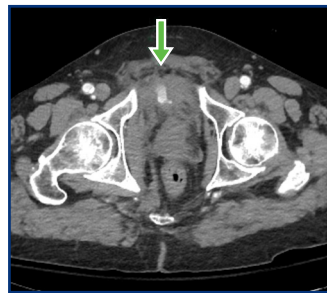
These images from the CT scan show a hematoma on the right side of the bleeding (red arrow), deviating the bladder to the left. In addition, there is active bleeding inferior to the bladder (green arrow).

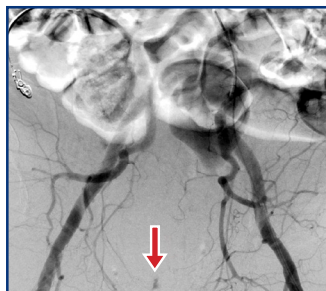
This image from the initial angiogram shows an area of active bleeding in the central portion of the pelvis (red arrow) which corresponded to the area on the CT scan.

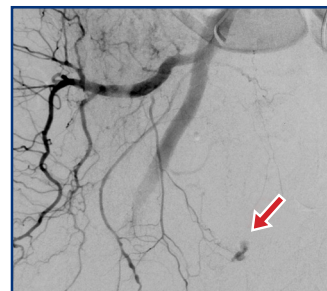
Angiography performed in an oblique projection shows the bleeding more clearly (red arrow) and also demonstrates the vessel where the bleeding is originating.

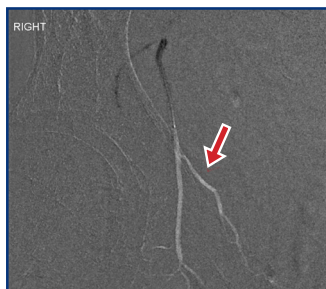
This image shows the source vessel and the target for catheterizing the labelled vessel.

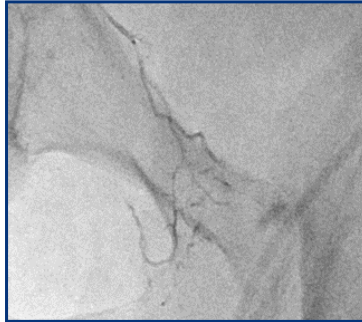
These images demonstrate how the LAVA occupies all branches of the target vessel.
